# BOWNESS BAY AND THE GLEBE

## SITE ANALYSIS

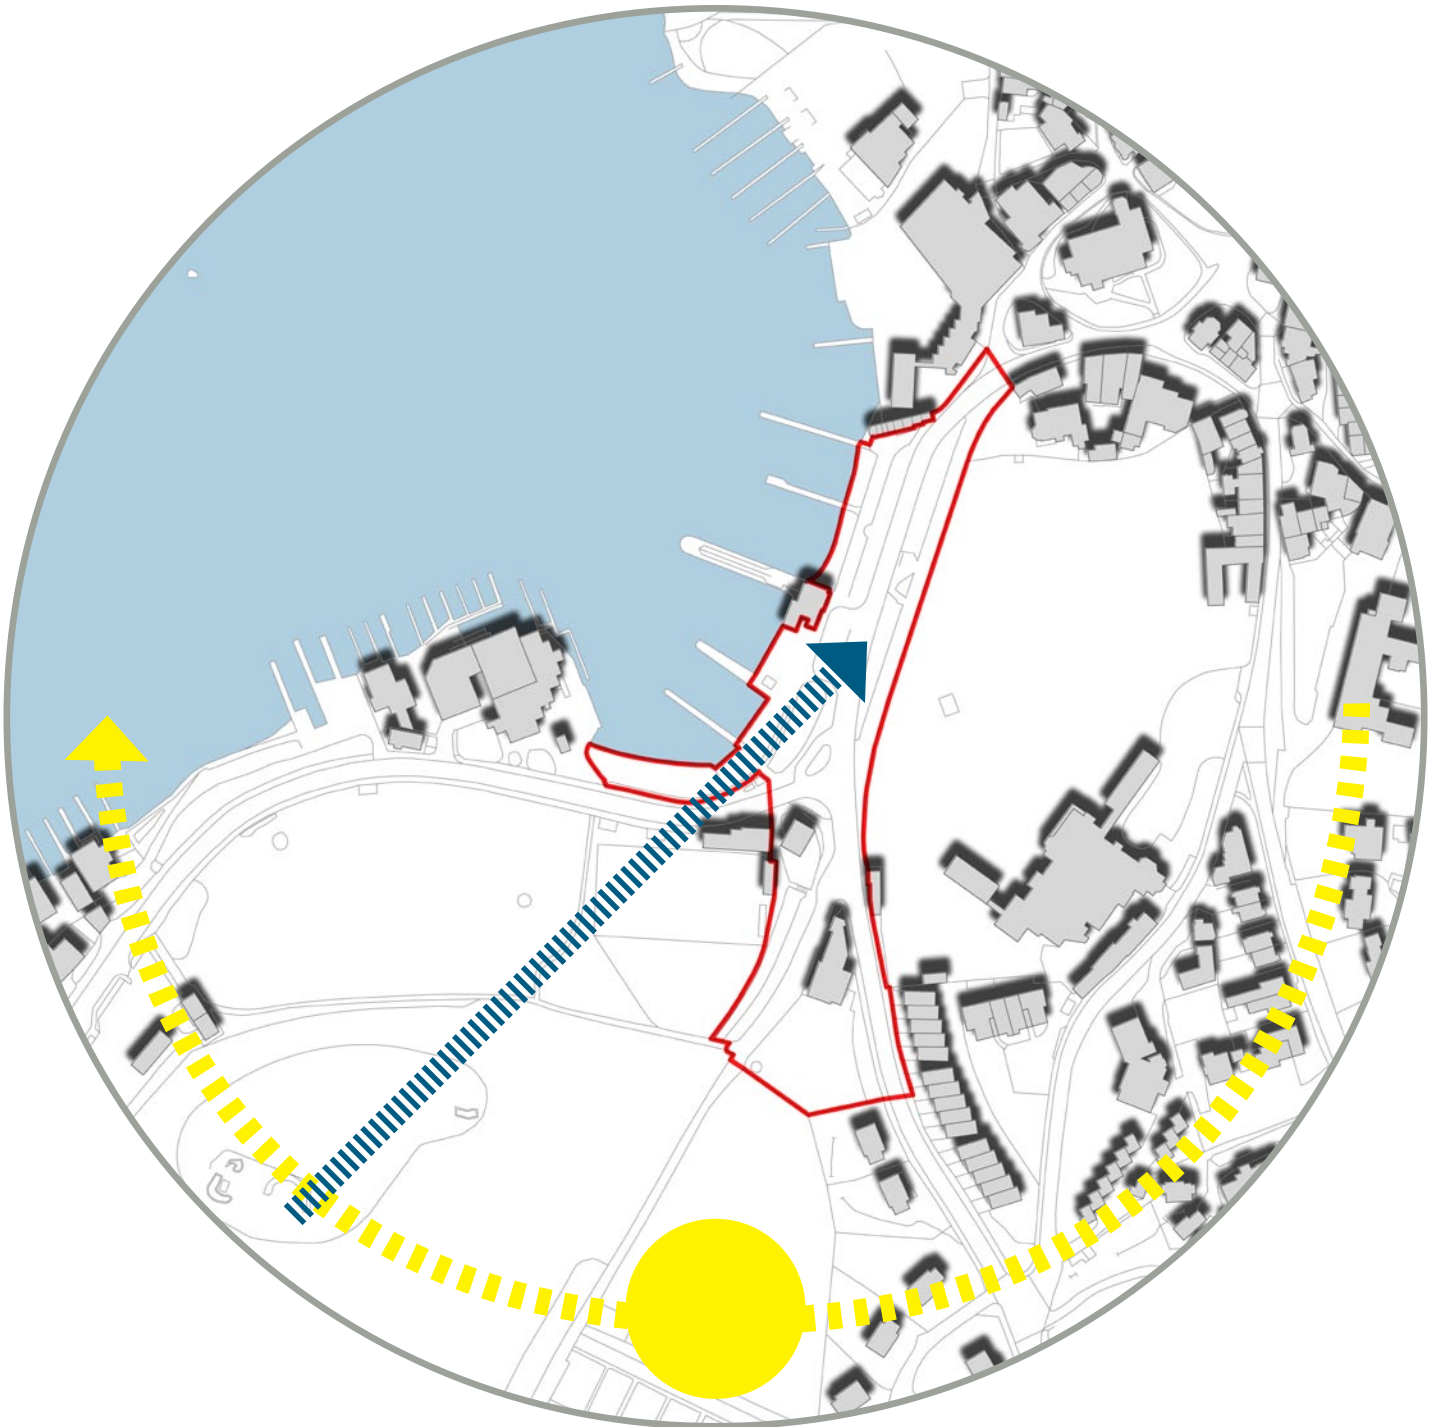
MICROCLIMATE

Direction of sun

Prevailing wind

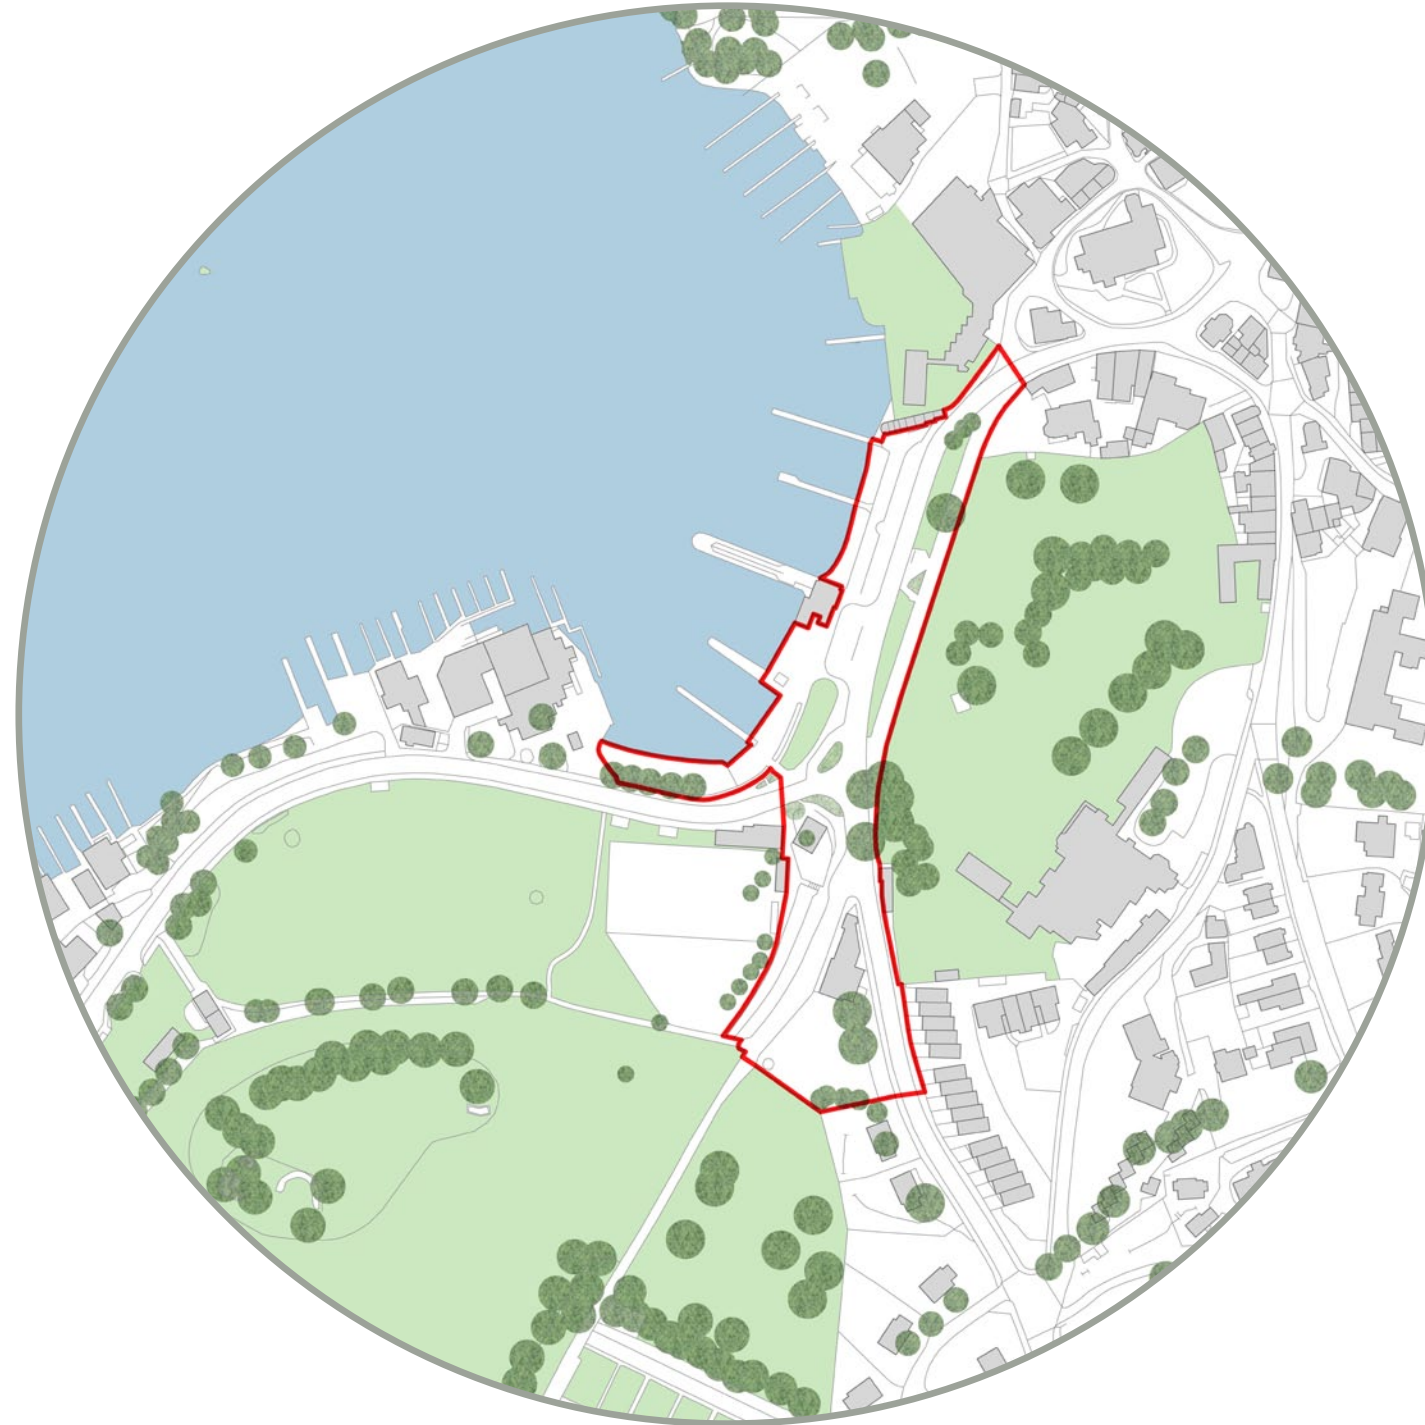
# EXISTING VEGETATION

Existing green space

Existing mature trees (approx only)

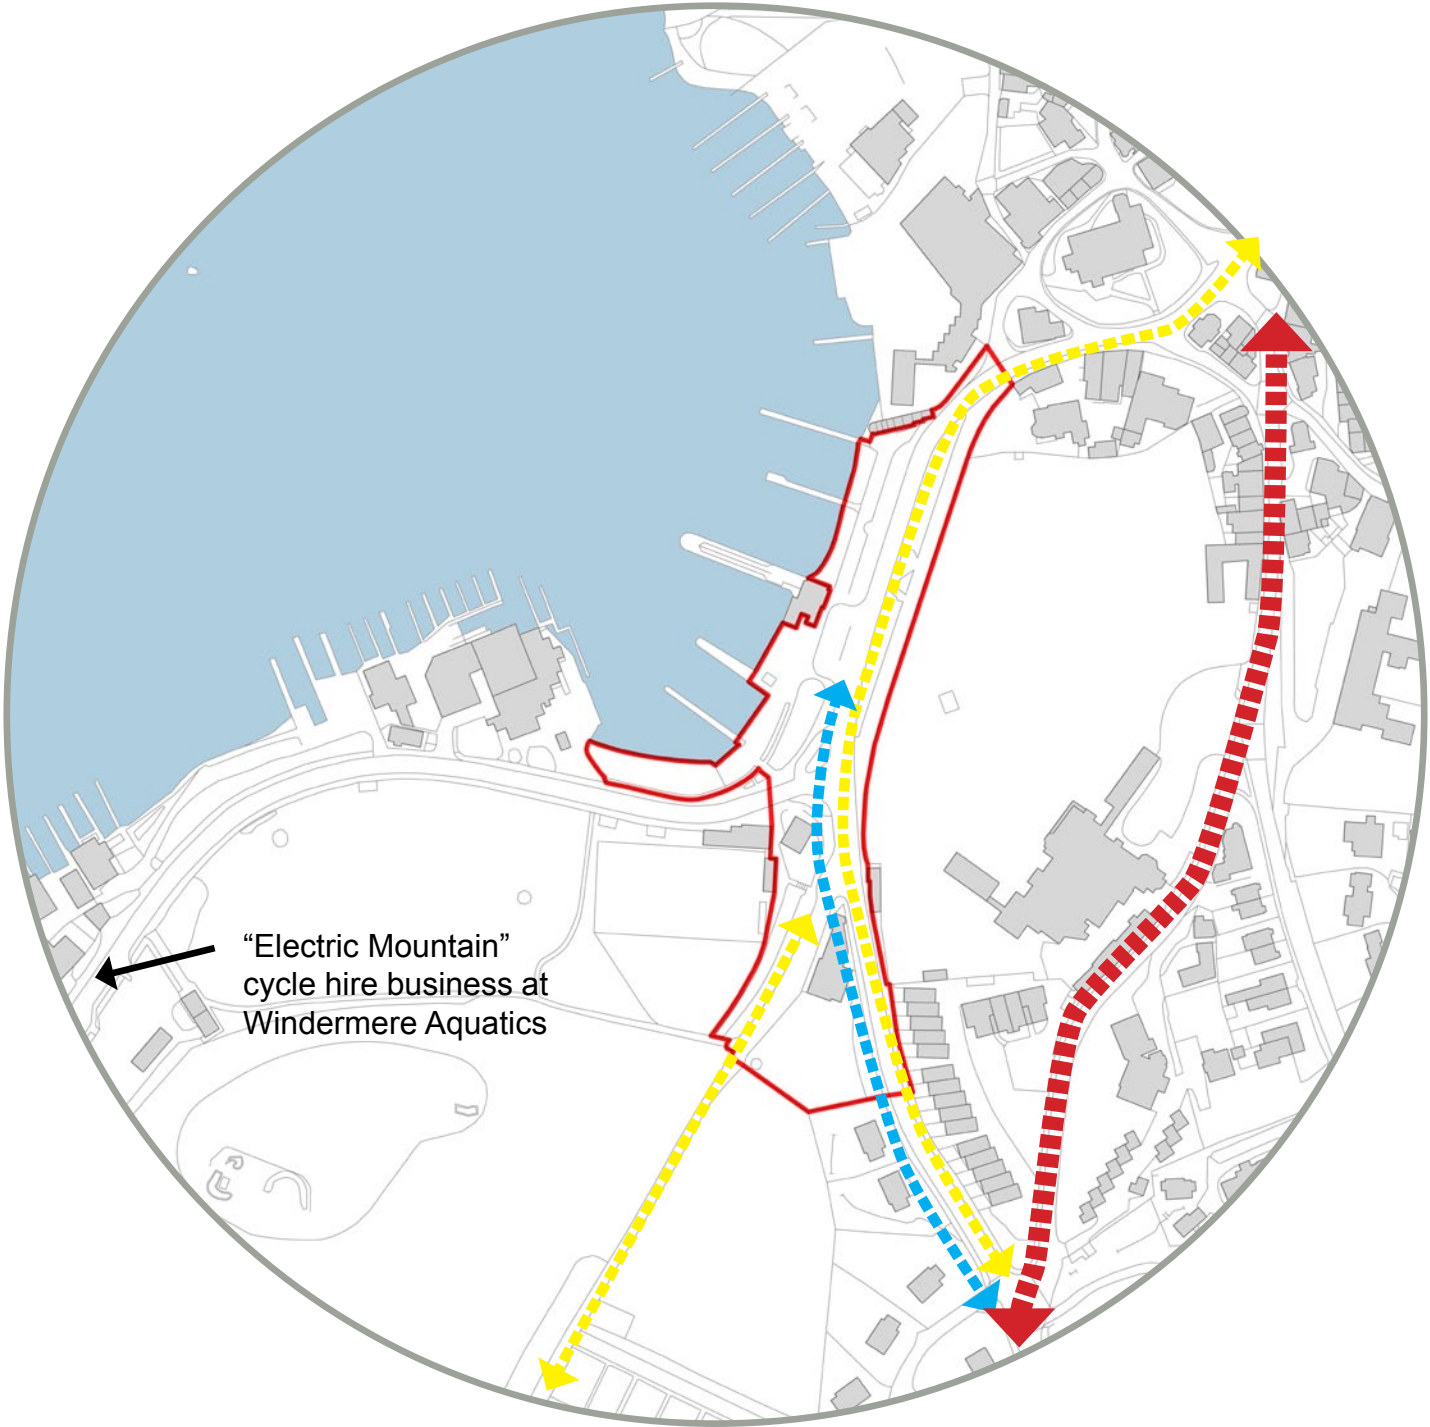
# CYCLE MOVEMENT

National Cycle Network Route 6  
(London to Threlkeld)

Informal Cycle Routes: with road markings

Informal Cycle Routes

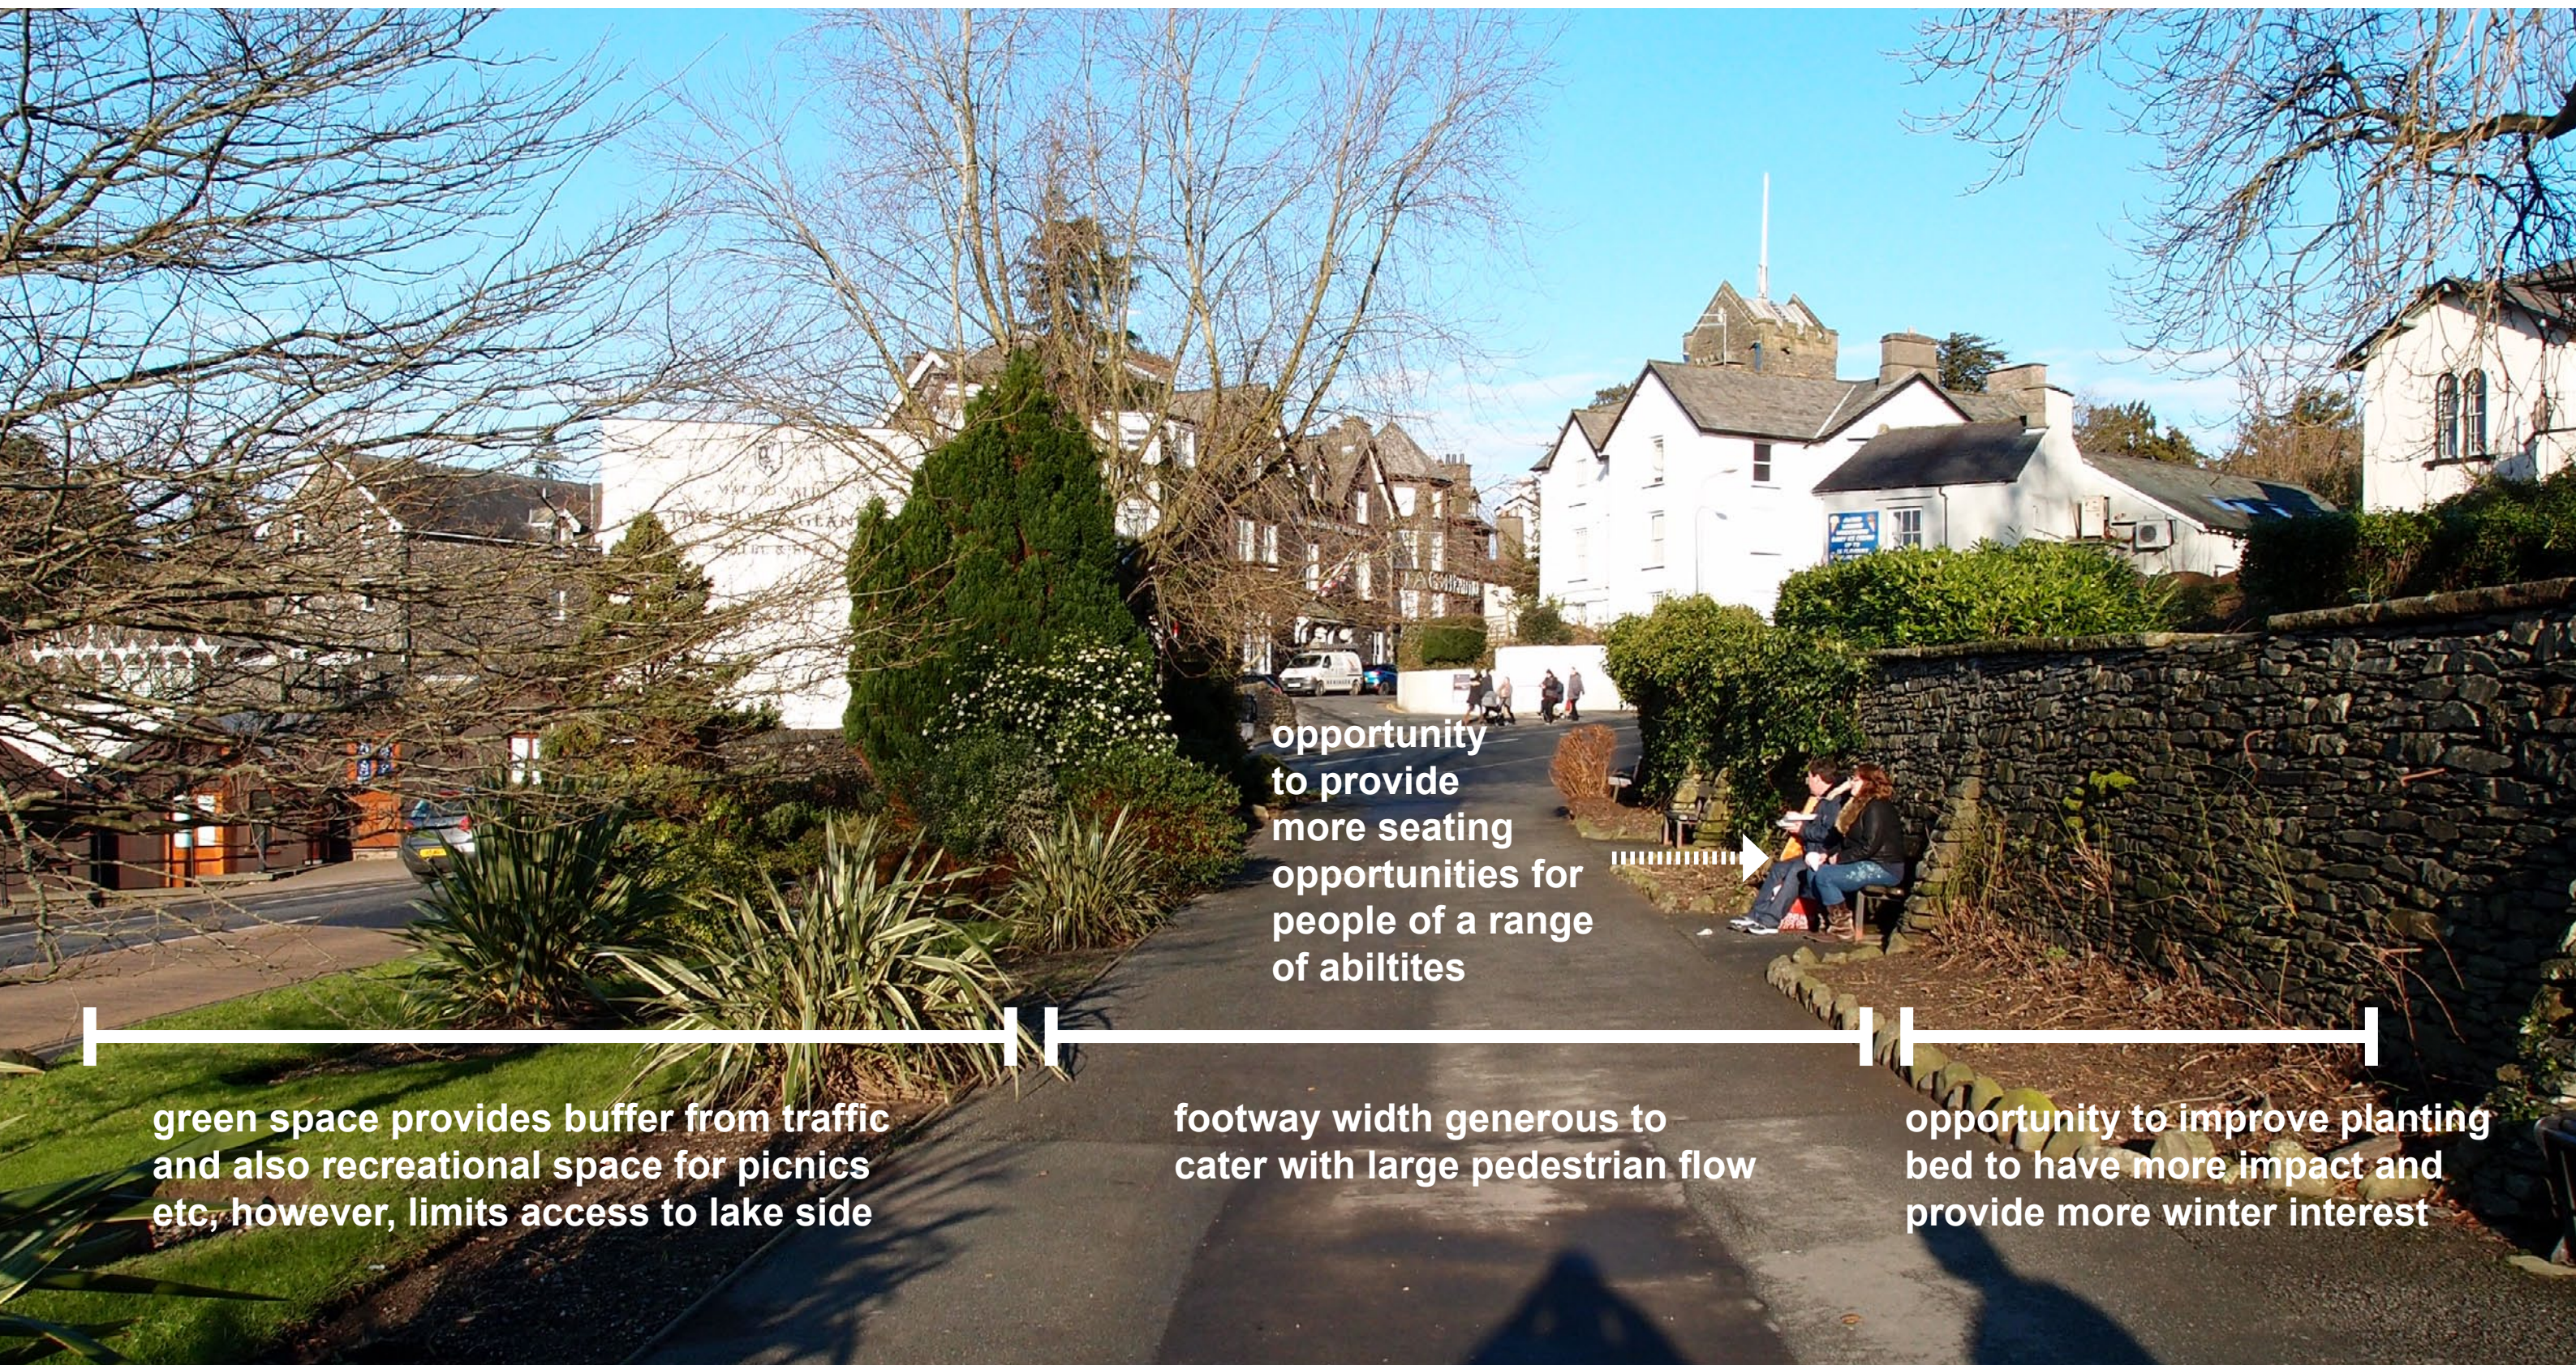
Vegetation  
screens formal  
crossing point

desire line to lake edge  
encourages pedestrians to  
step out into traffic

pinch point in footway  
forces pedestrians to  
step out into traffic

change of surface  
in carriageway  
provides informal  
crossing point

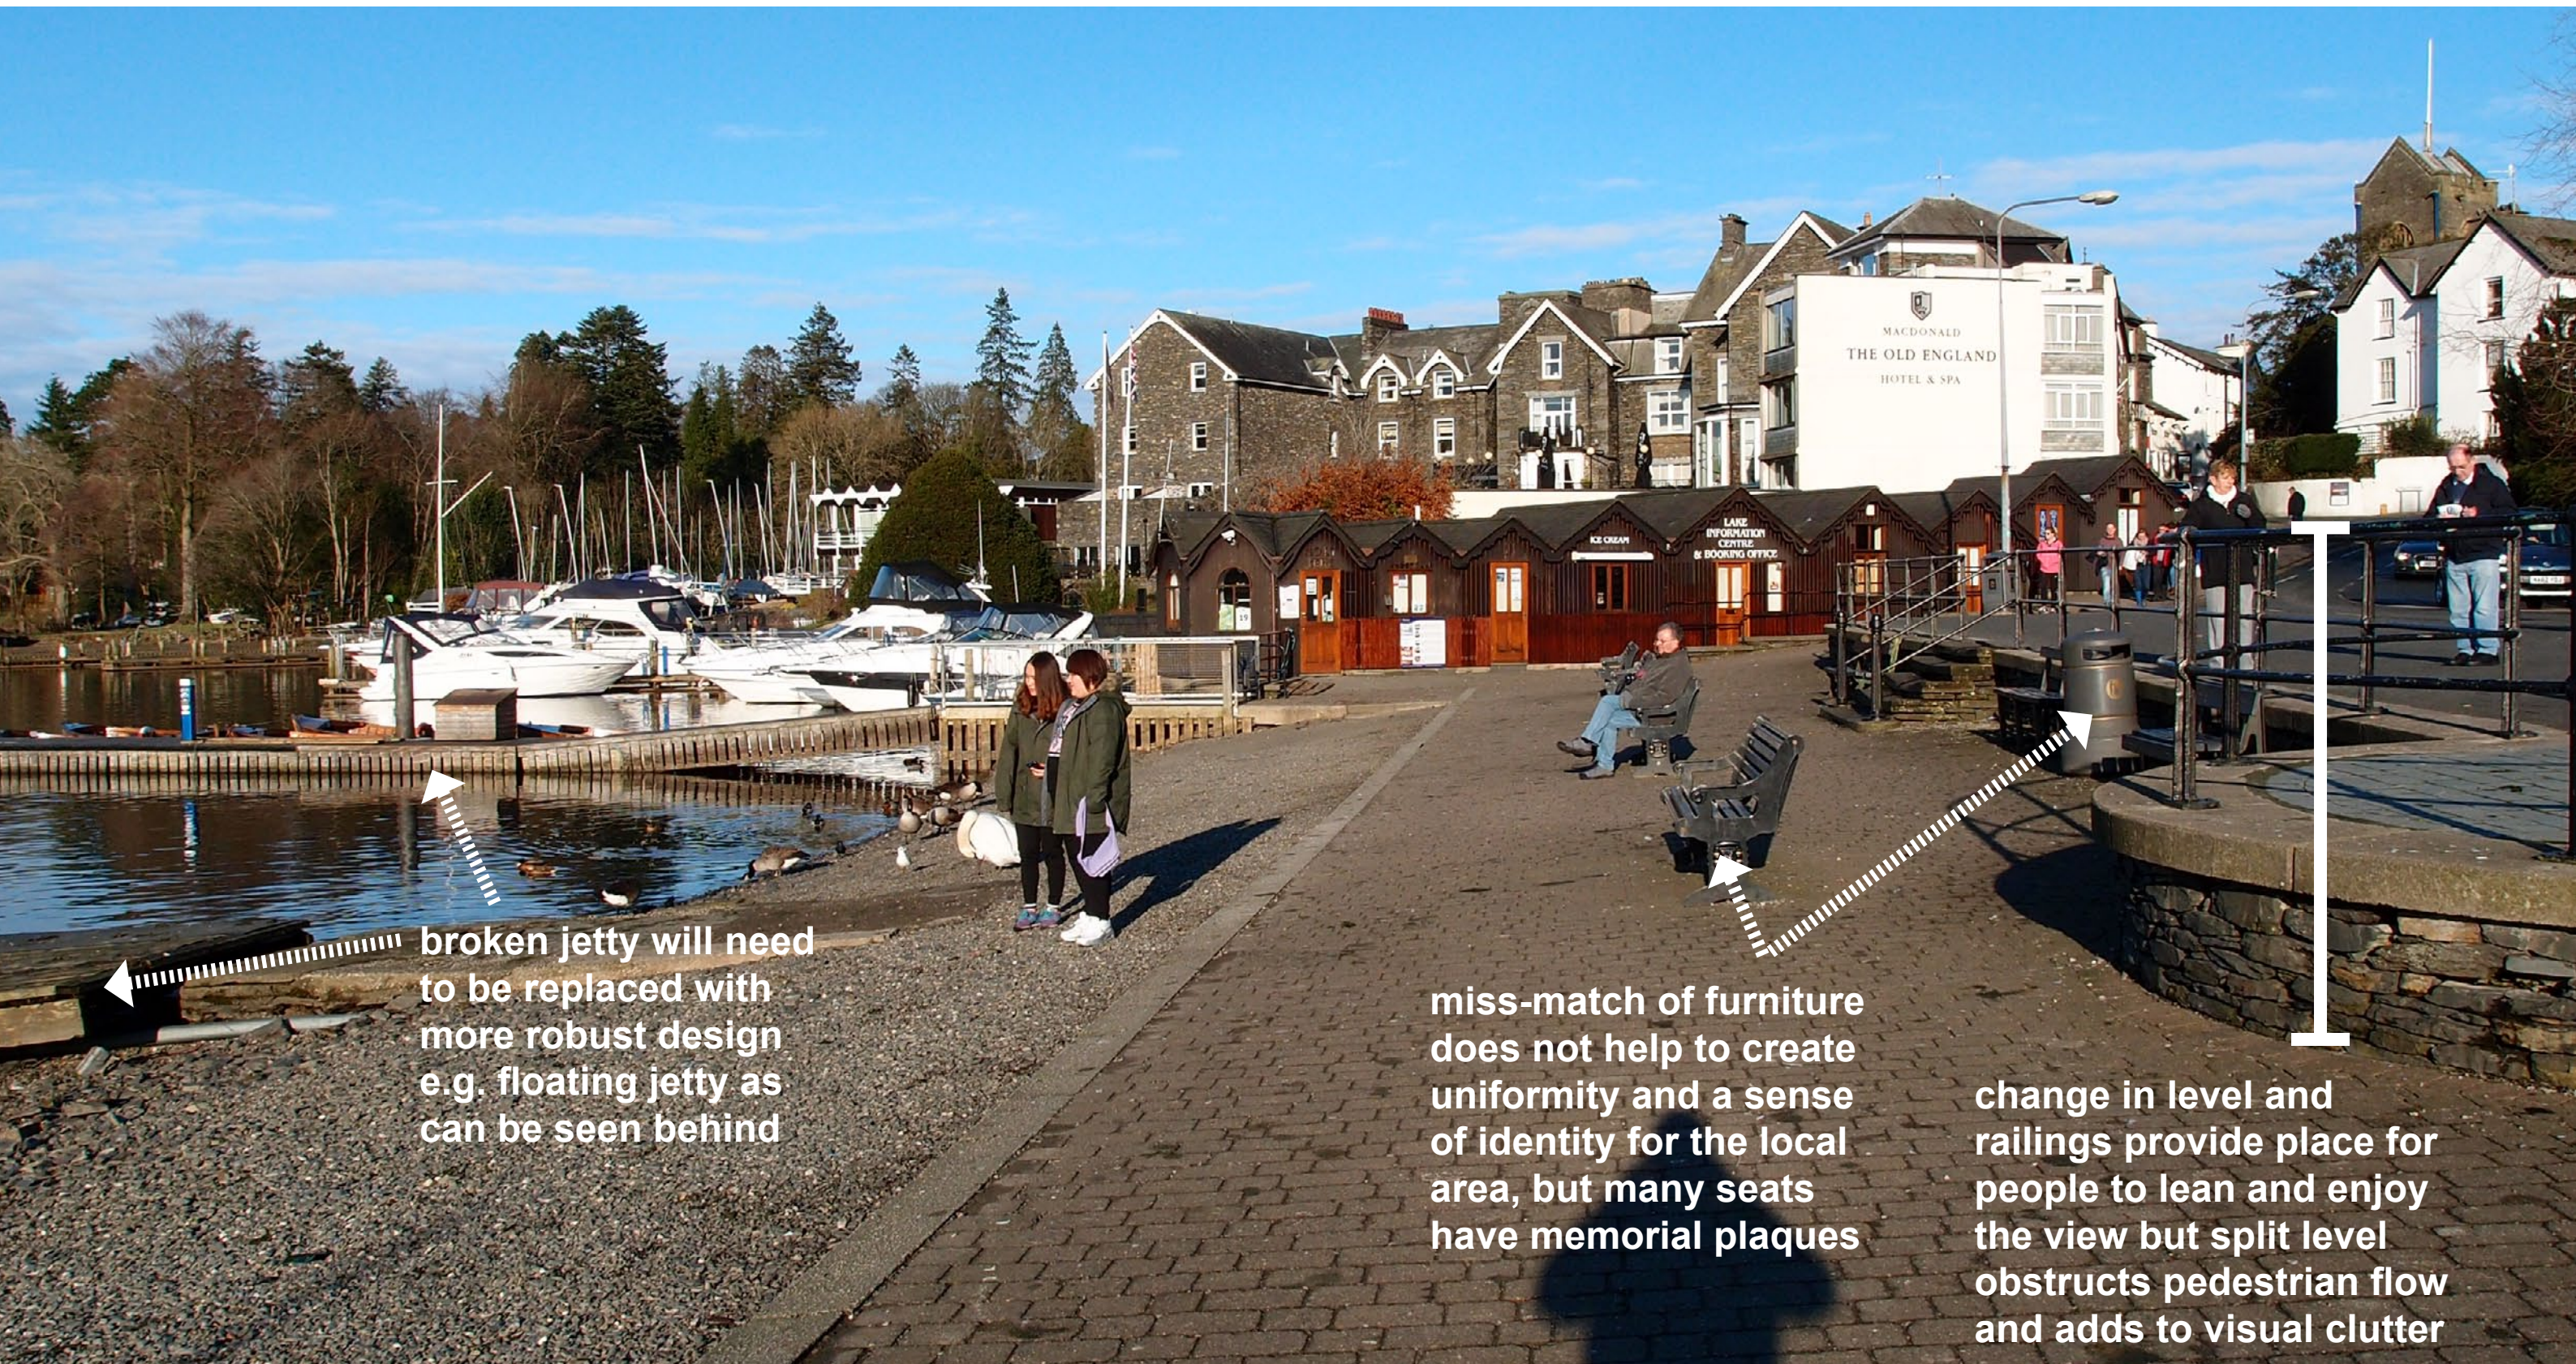
green space provides buffer from traffic and also recreational space for picnics etc, however, limits access to lake side

footway width generous to cater with large pedestrian flow

opportunity to provide more seating opportunities for people of a range of abilities

opportunity to improve planting bed to have more impact and provide more winter interest

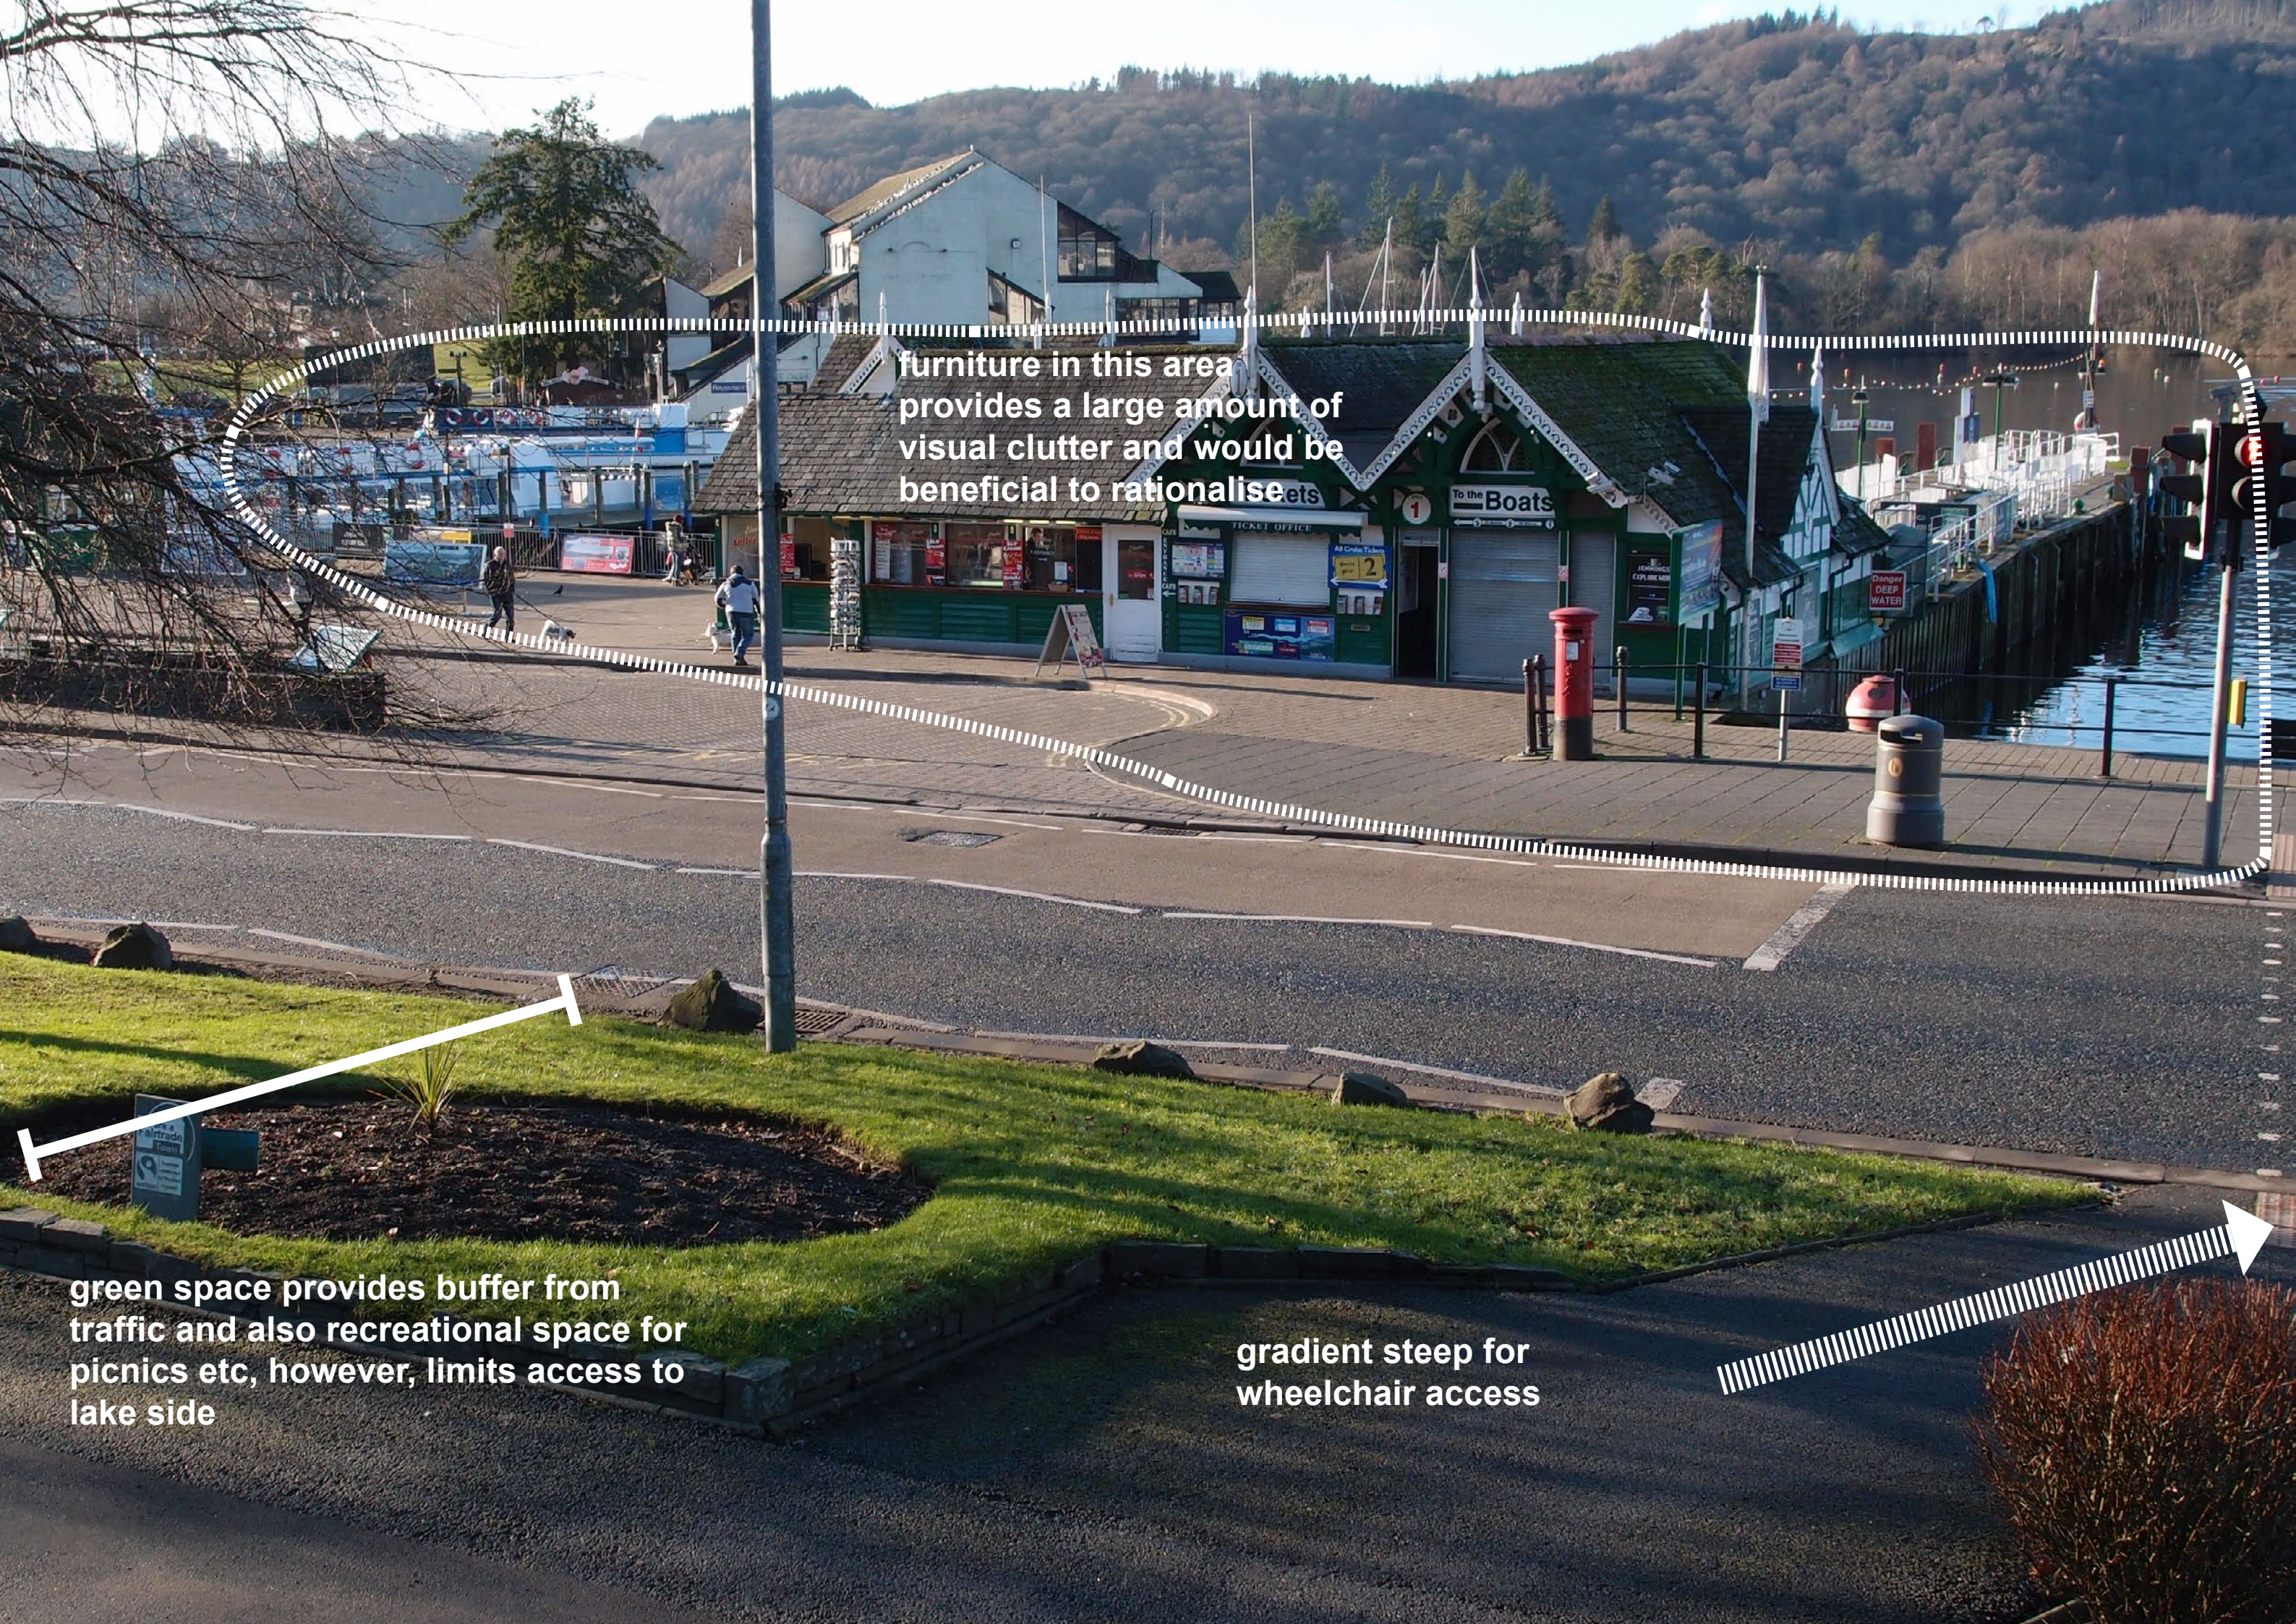
crossing points do  
not necessarily follow  
natural desire lines

fantastic open views across the  
lake should not be enhanced and  
not obstructed

opportunity to  
improve planting

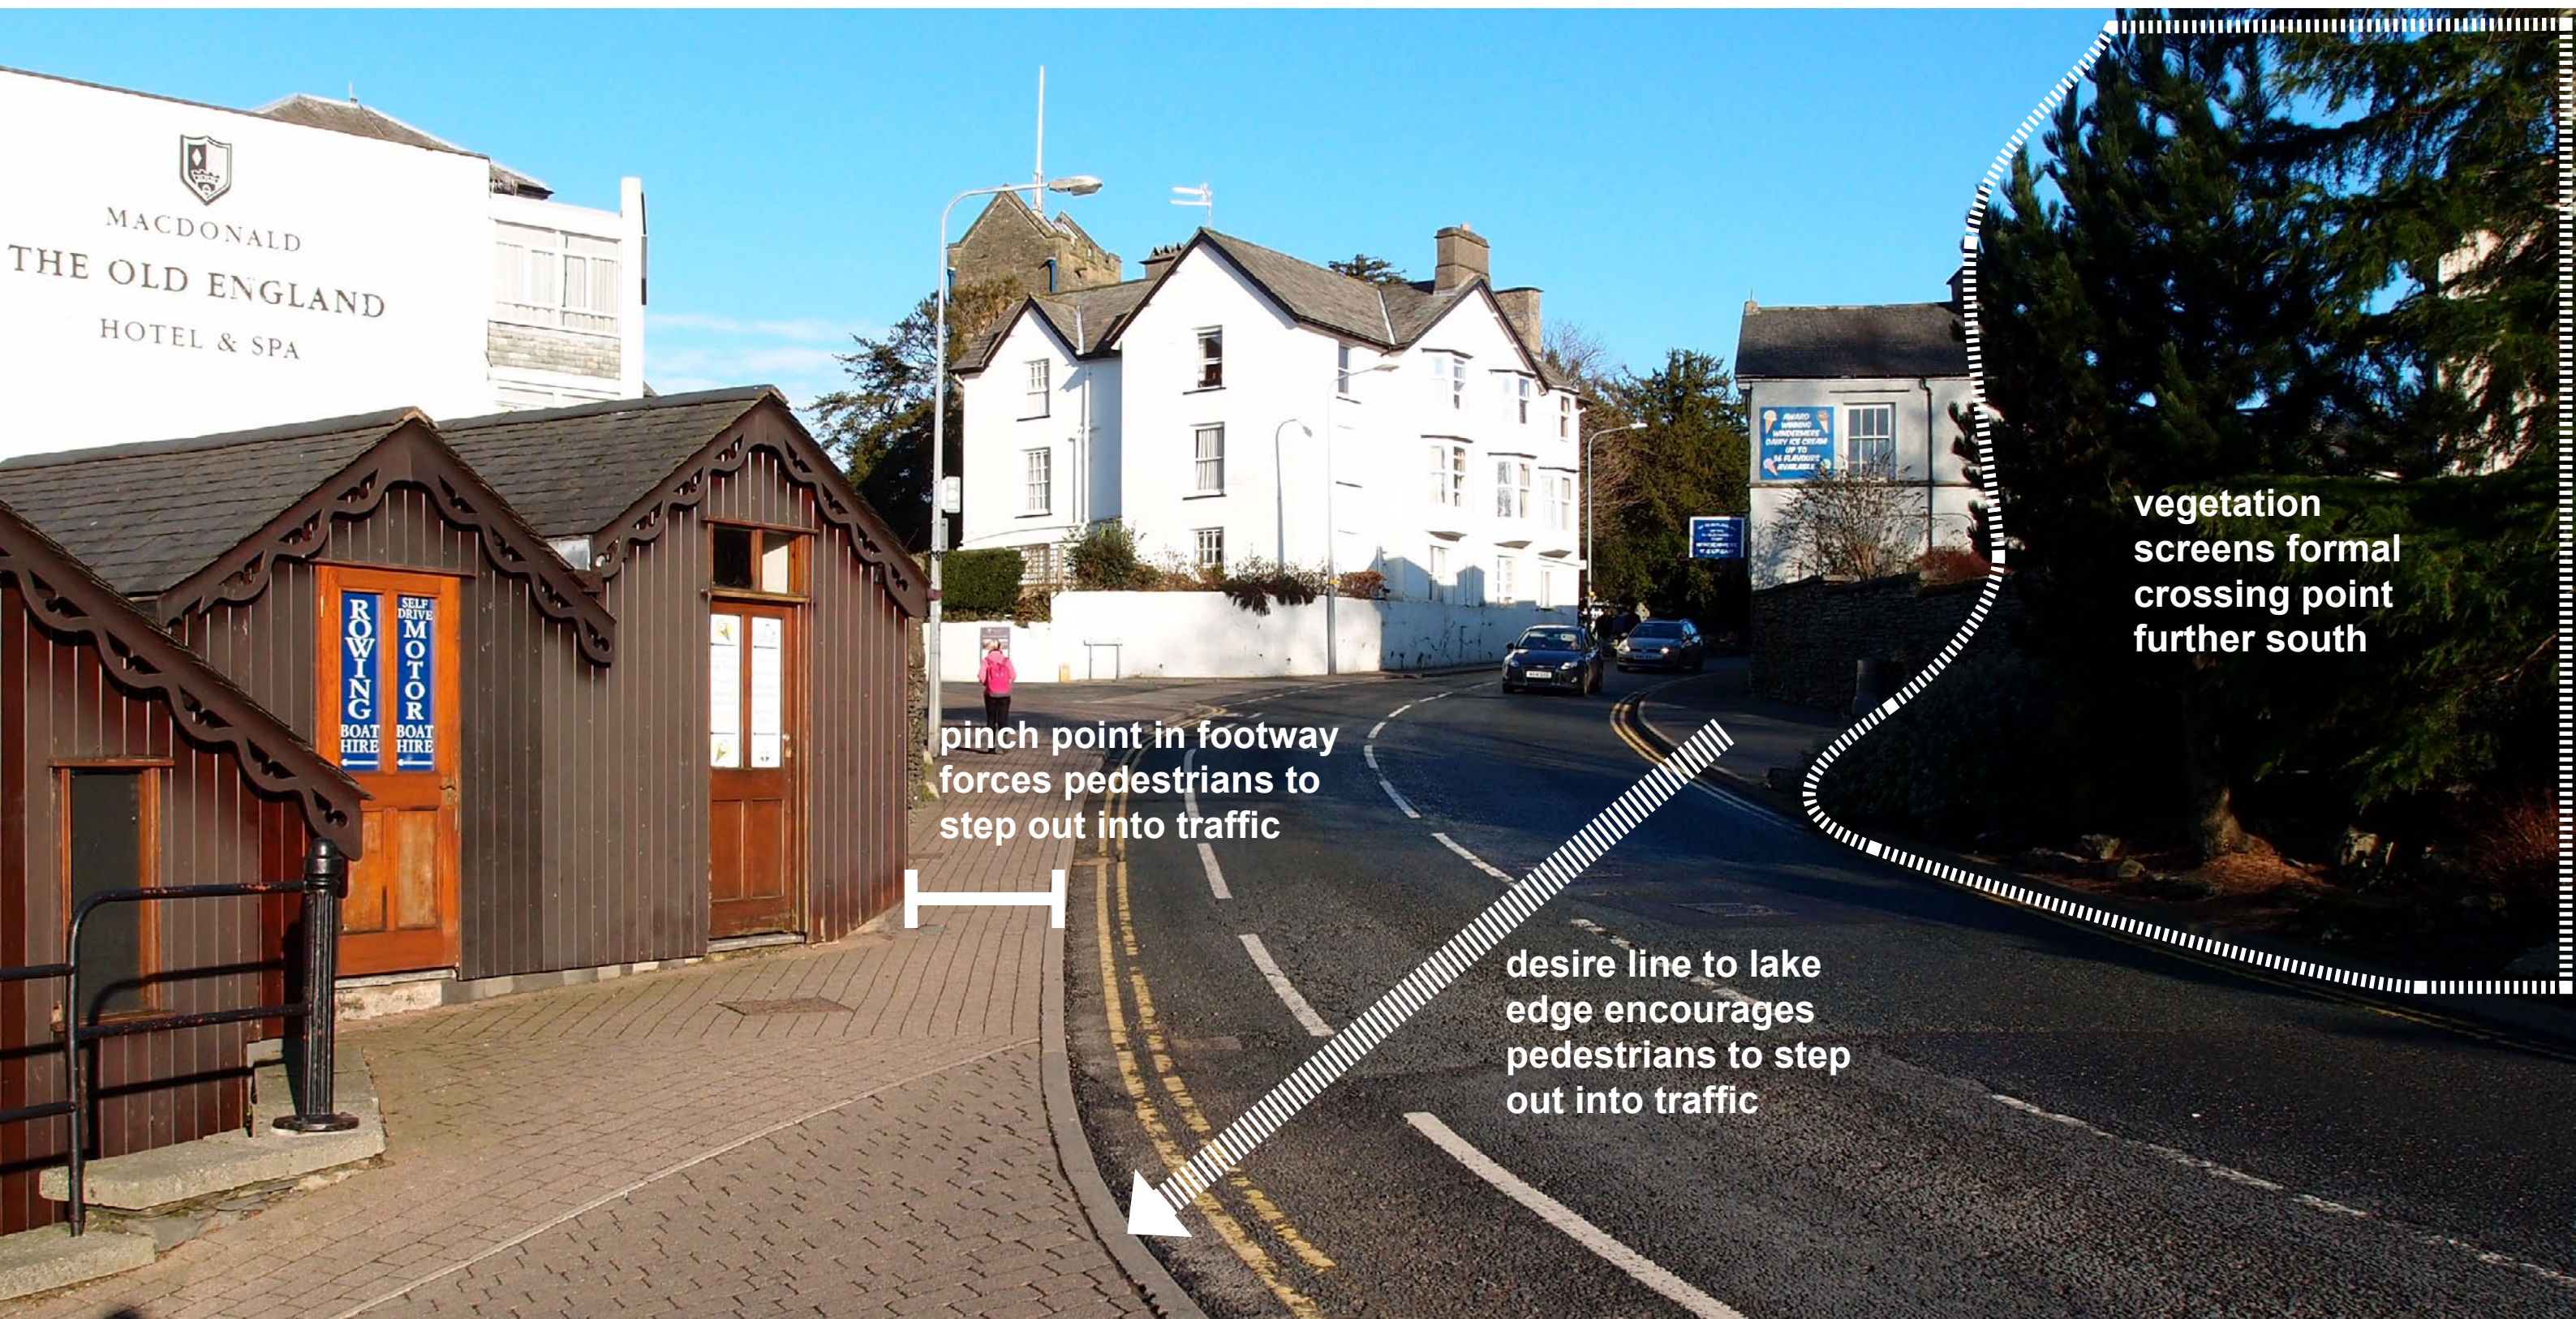
furniture in this area provides a large amount of visual clutter and would be beneficial to rationalise

green space provides buffer from traffic and also recreational space for picnics etc, however, limits access to lake side

gradient steep for wheelchair access
