# BOWNESS BAY AND THE GLEBE

## SITE ANALYSIS

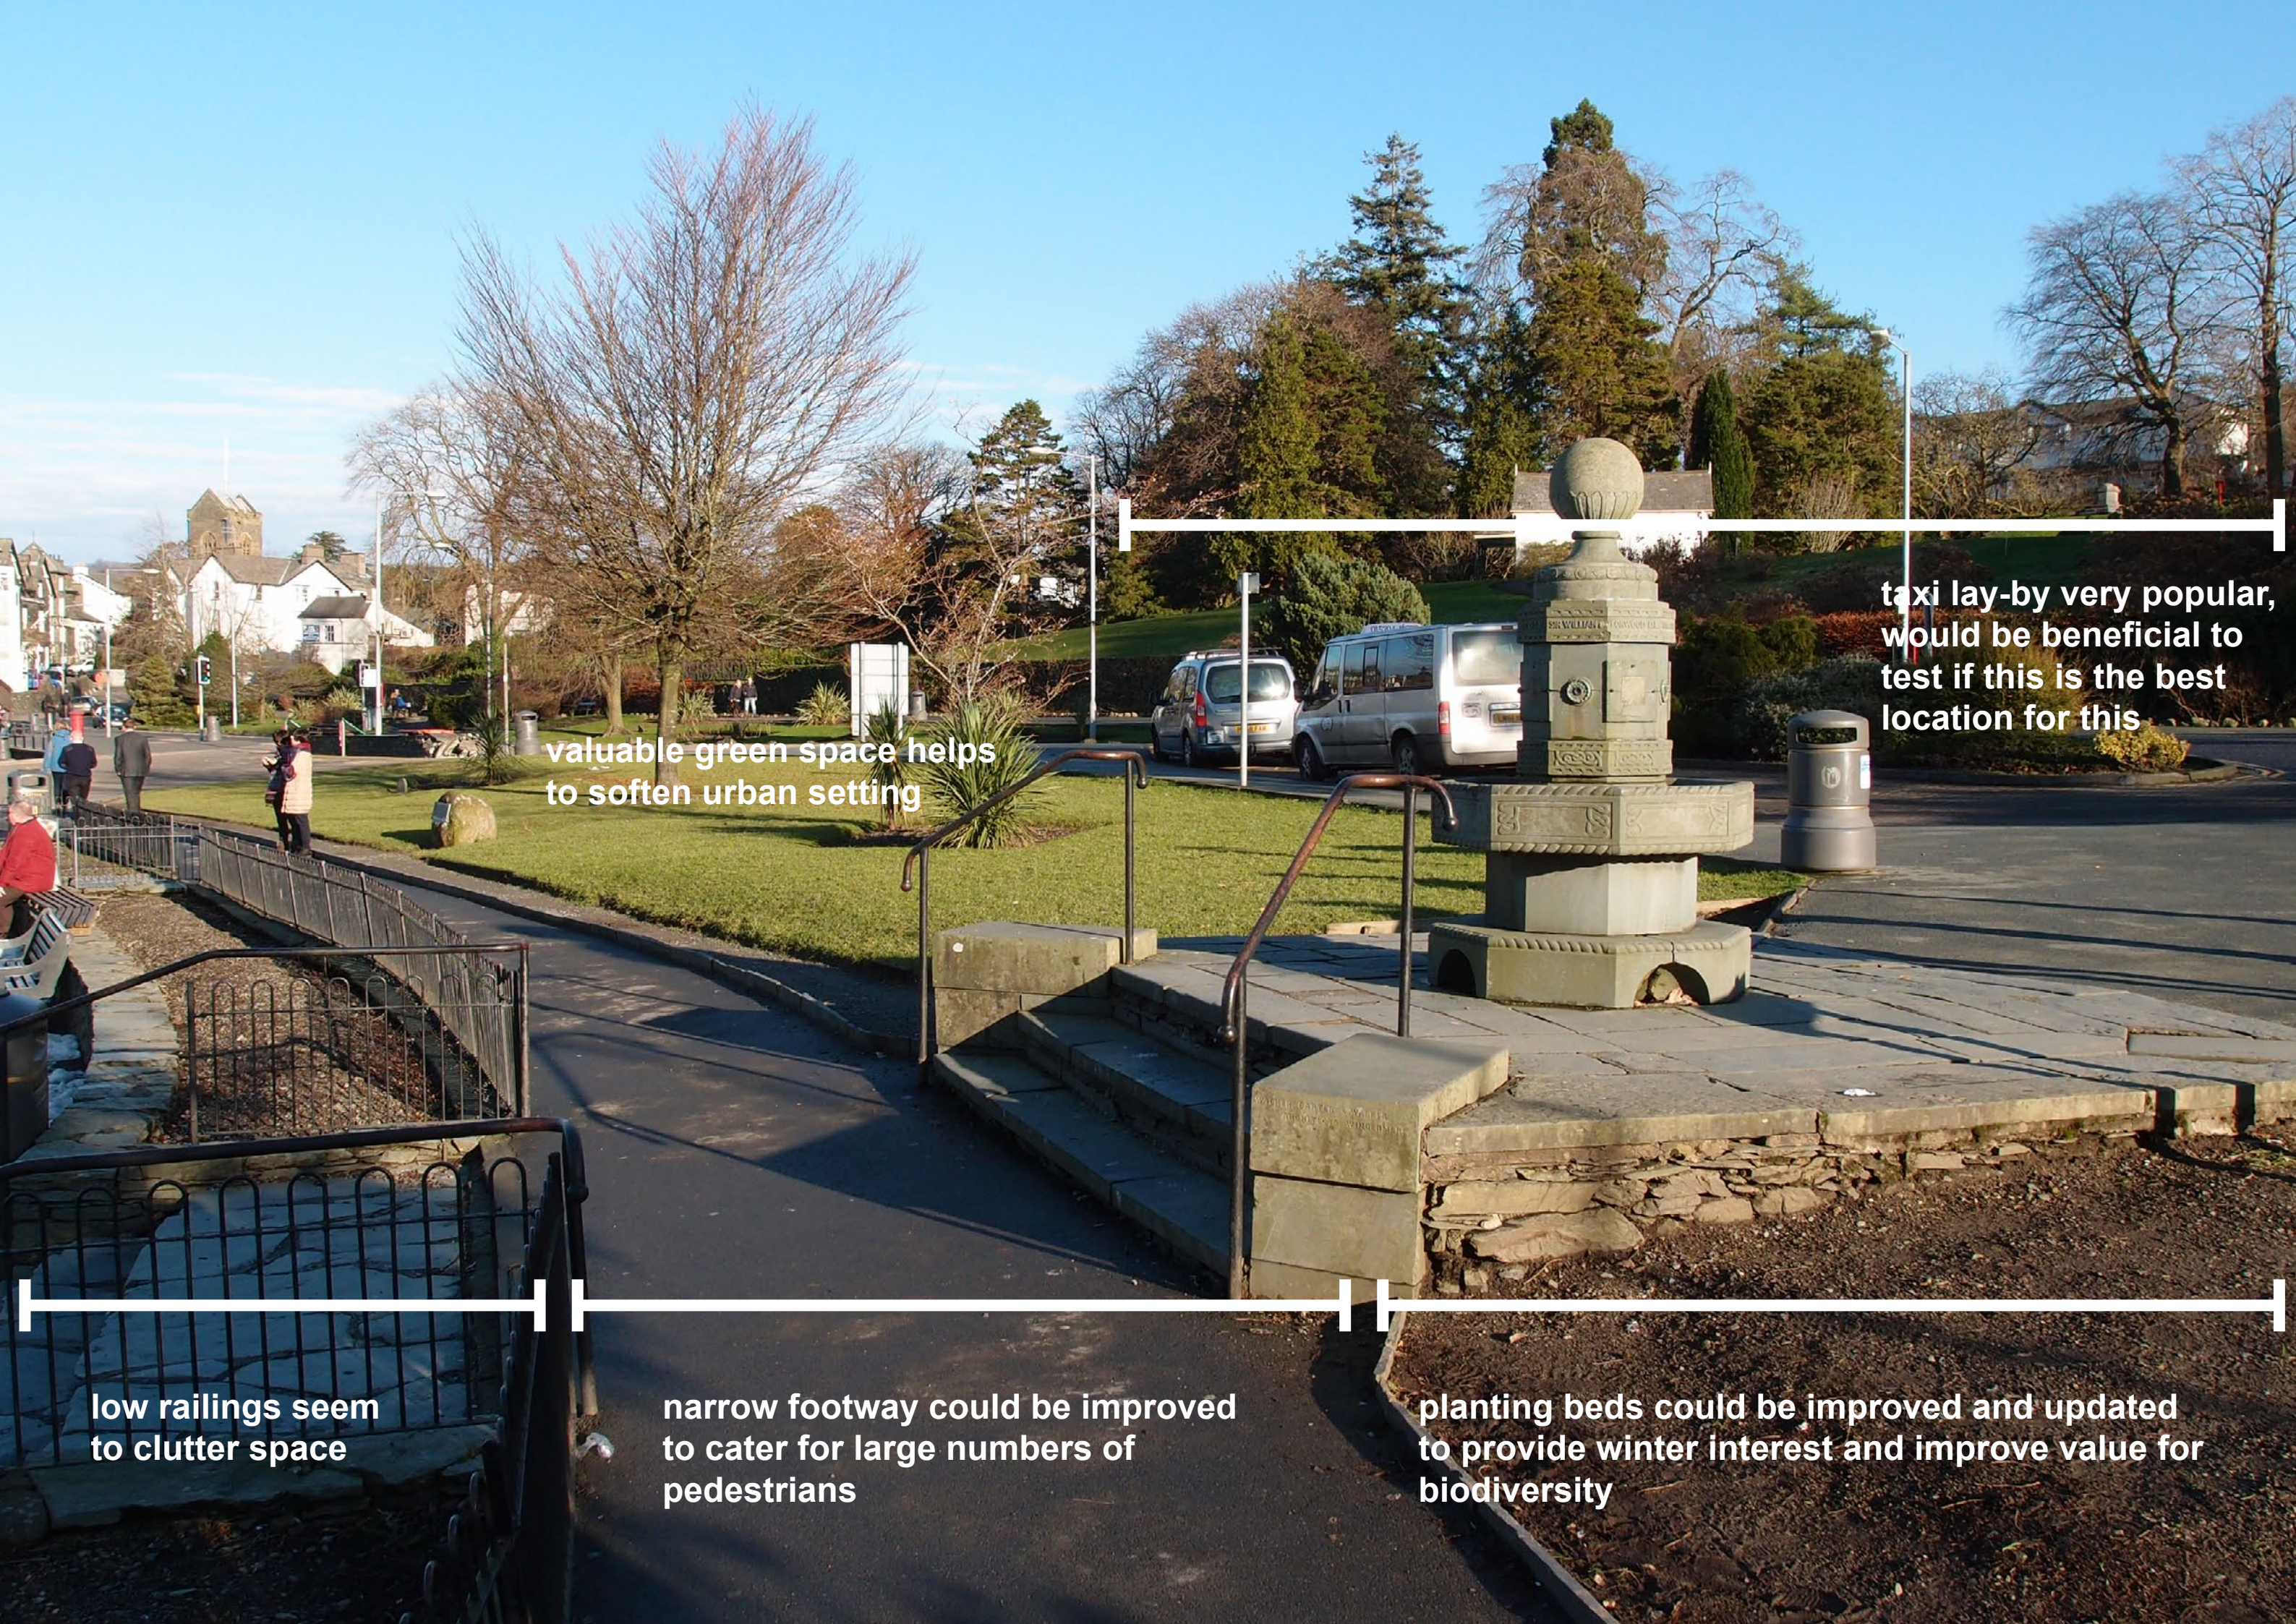
pinch point in footway  
forces pedestrians to  
step out into traffic

desire line to lake  
edge encourages  
pedestrians to step  
out into traffic

vegetation  
screens formal  
crossing point  
further south

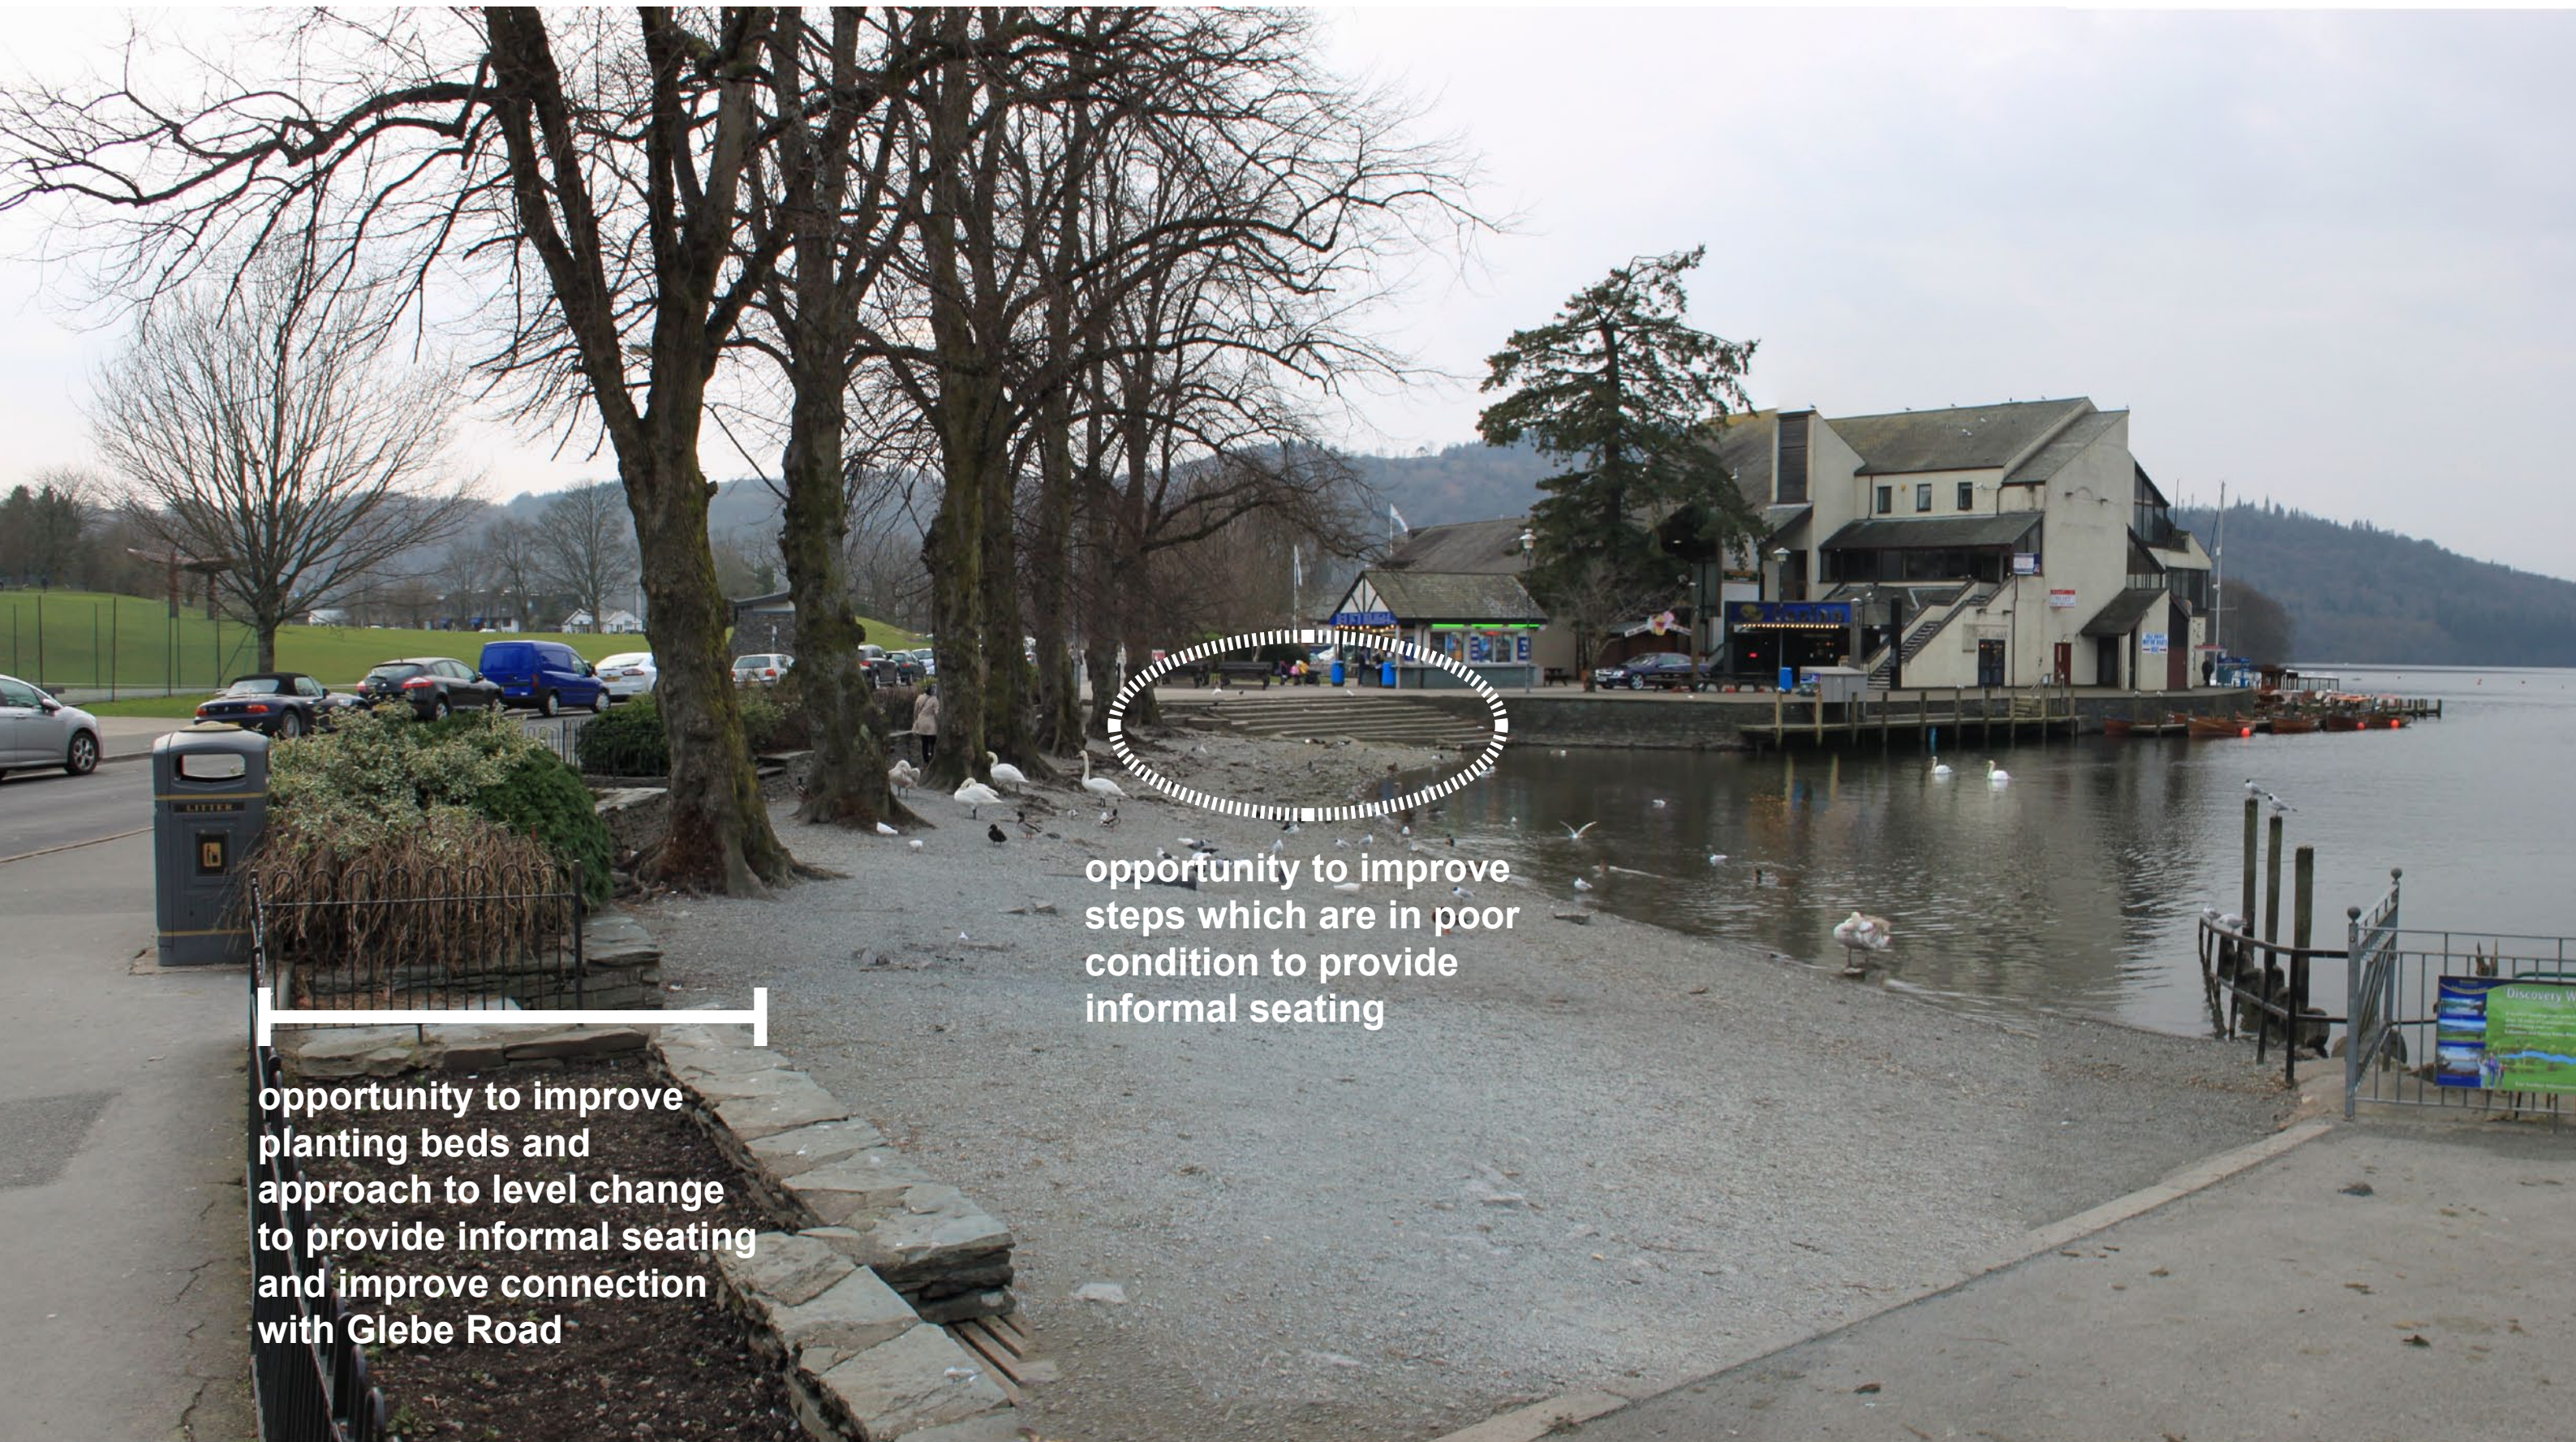
wider area of footway ideal for catering with large visitor numbers

shared use of lay-by with leisure coaches to drop off visitors and provide easy access to lake and boats

pinch point in footway

public bus stop does not currently provide wheelchair access from kerb

evidence of lack of turning space

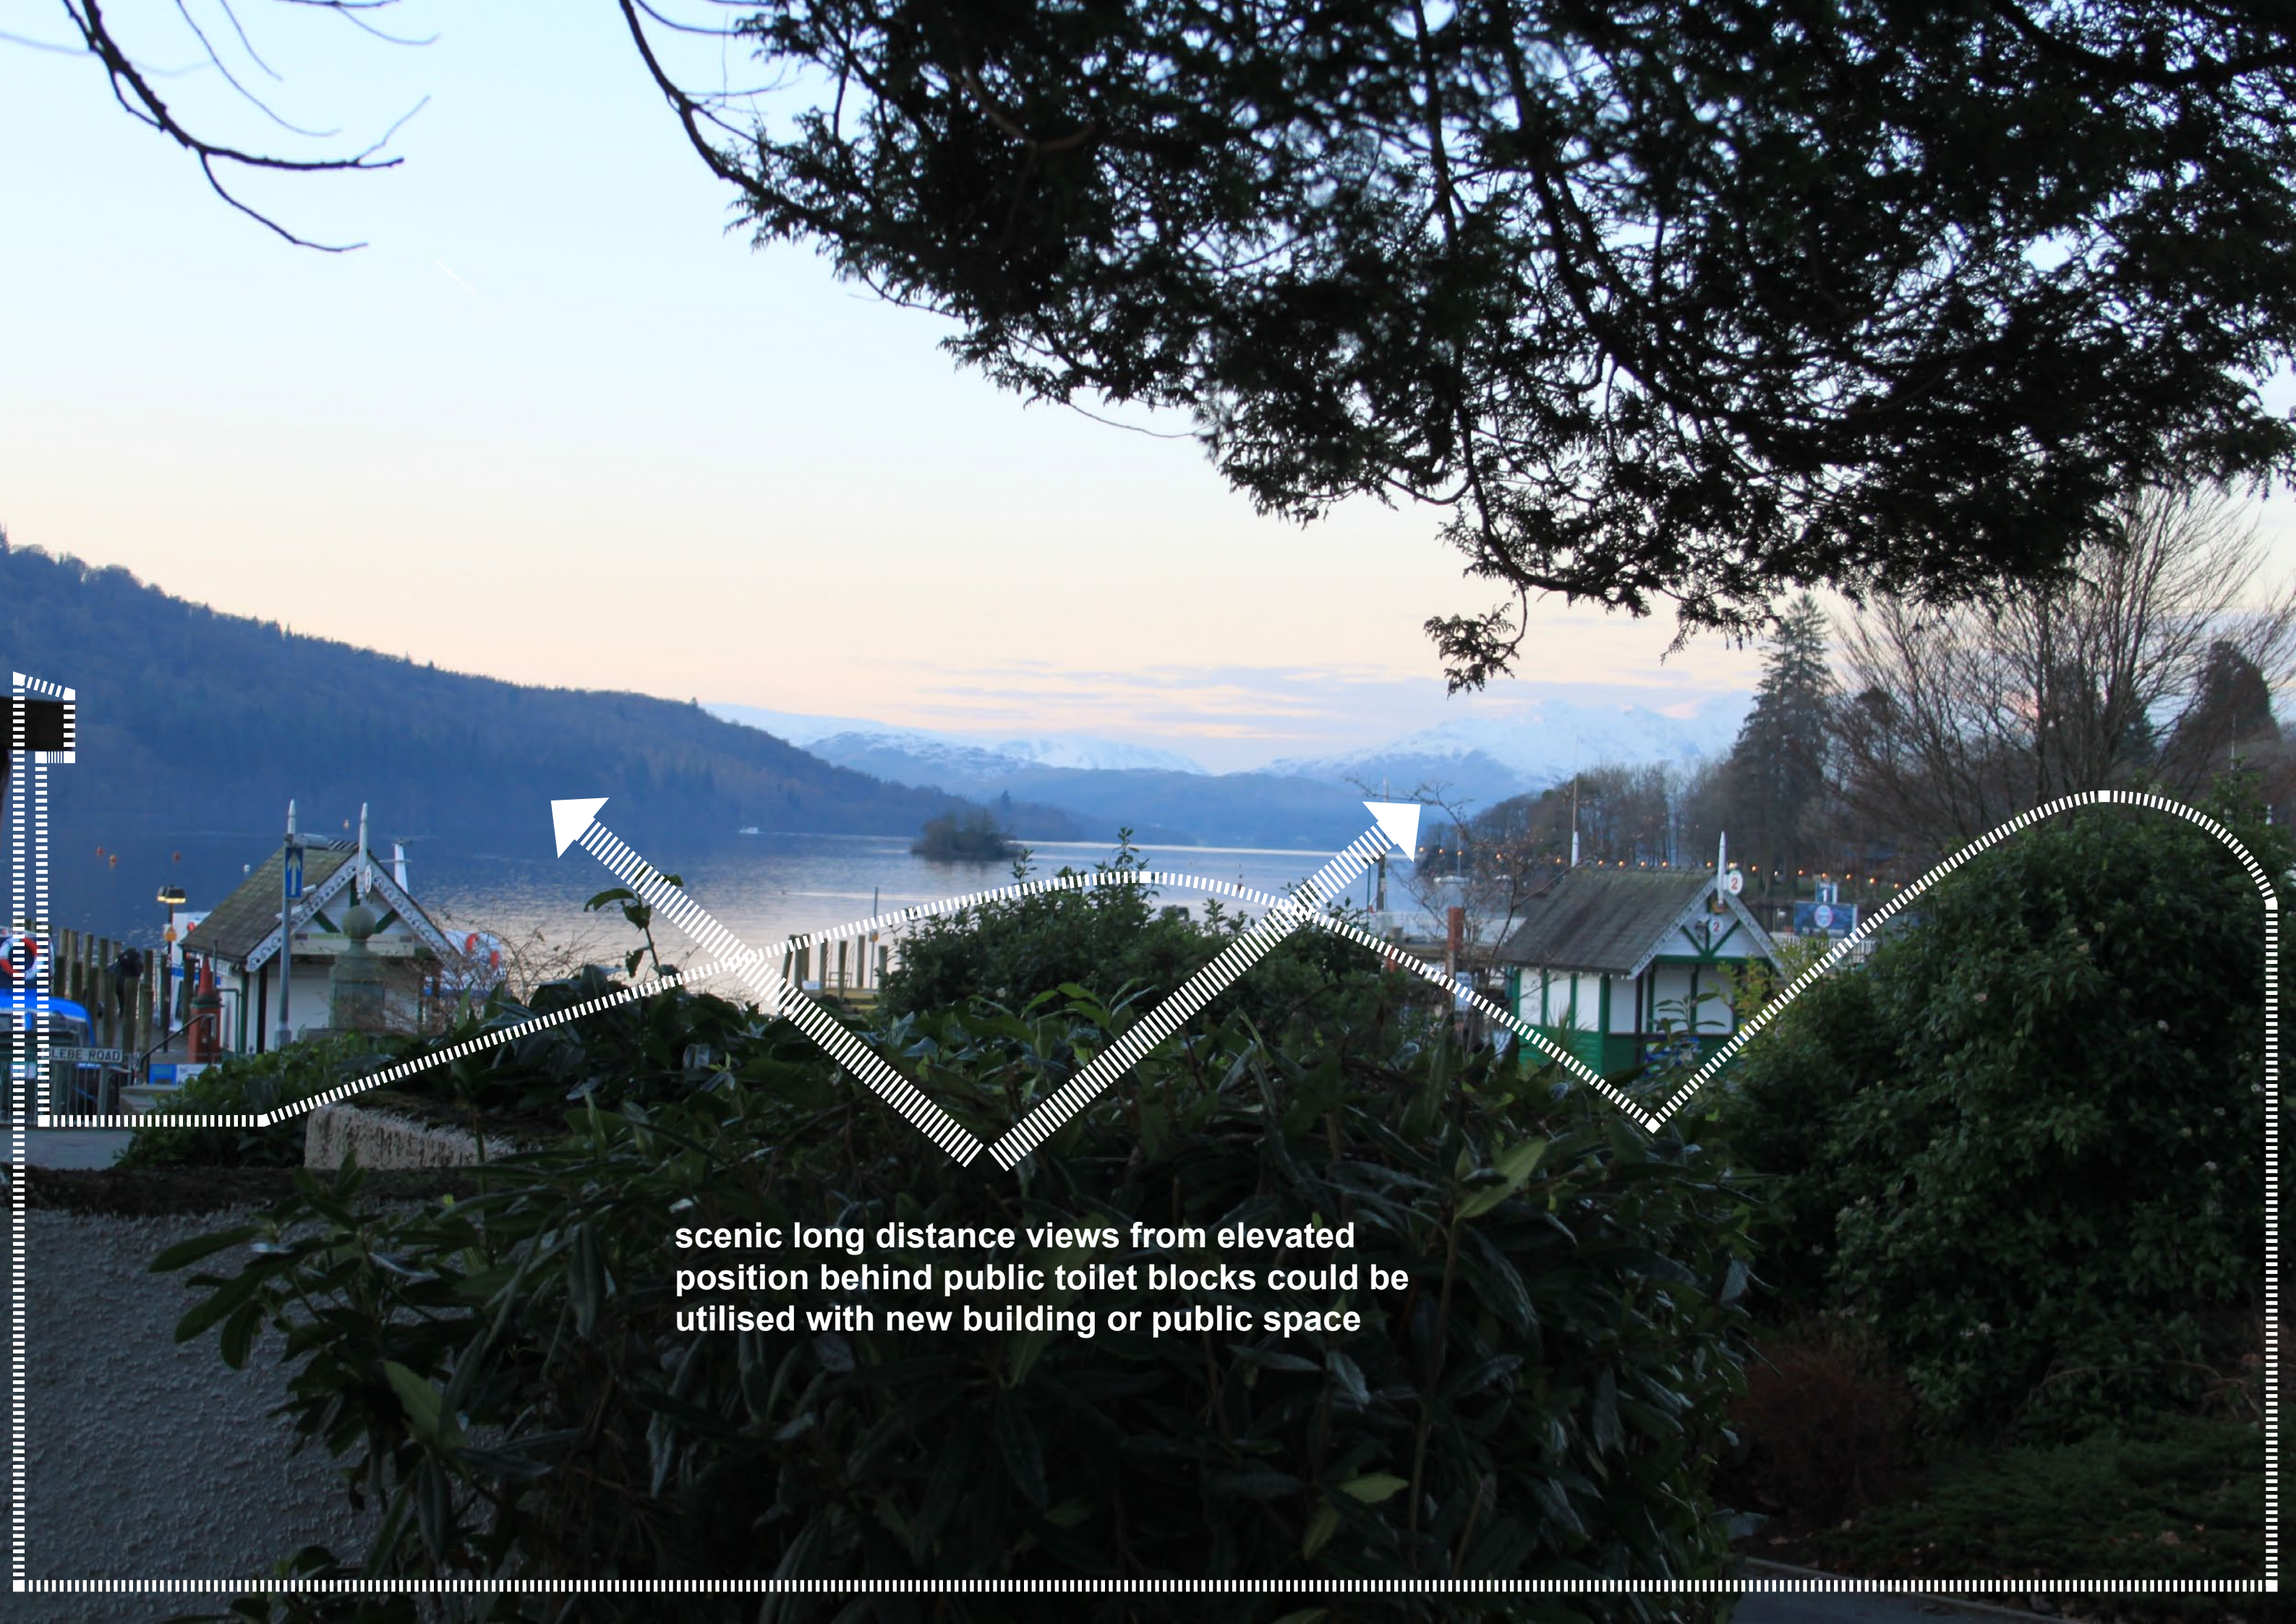
opportunity to improve  
planting beds and  
approach to level change  
to provide informal seating  
and improve connection  
with Glebe Road

opportunity to improve  
steps which are in poor  
condition to provide  
informal seating

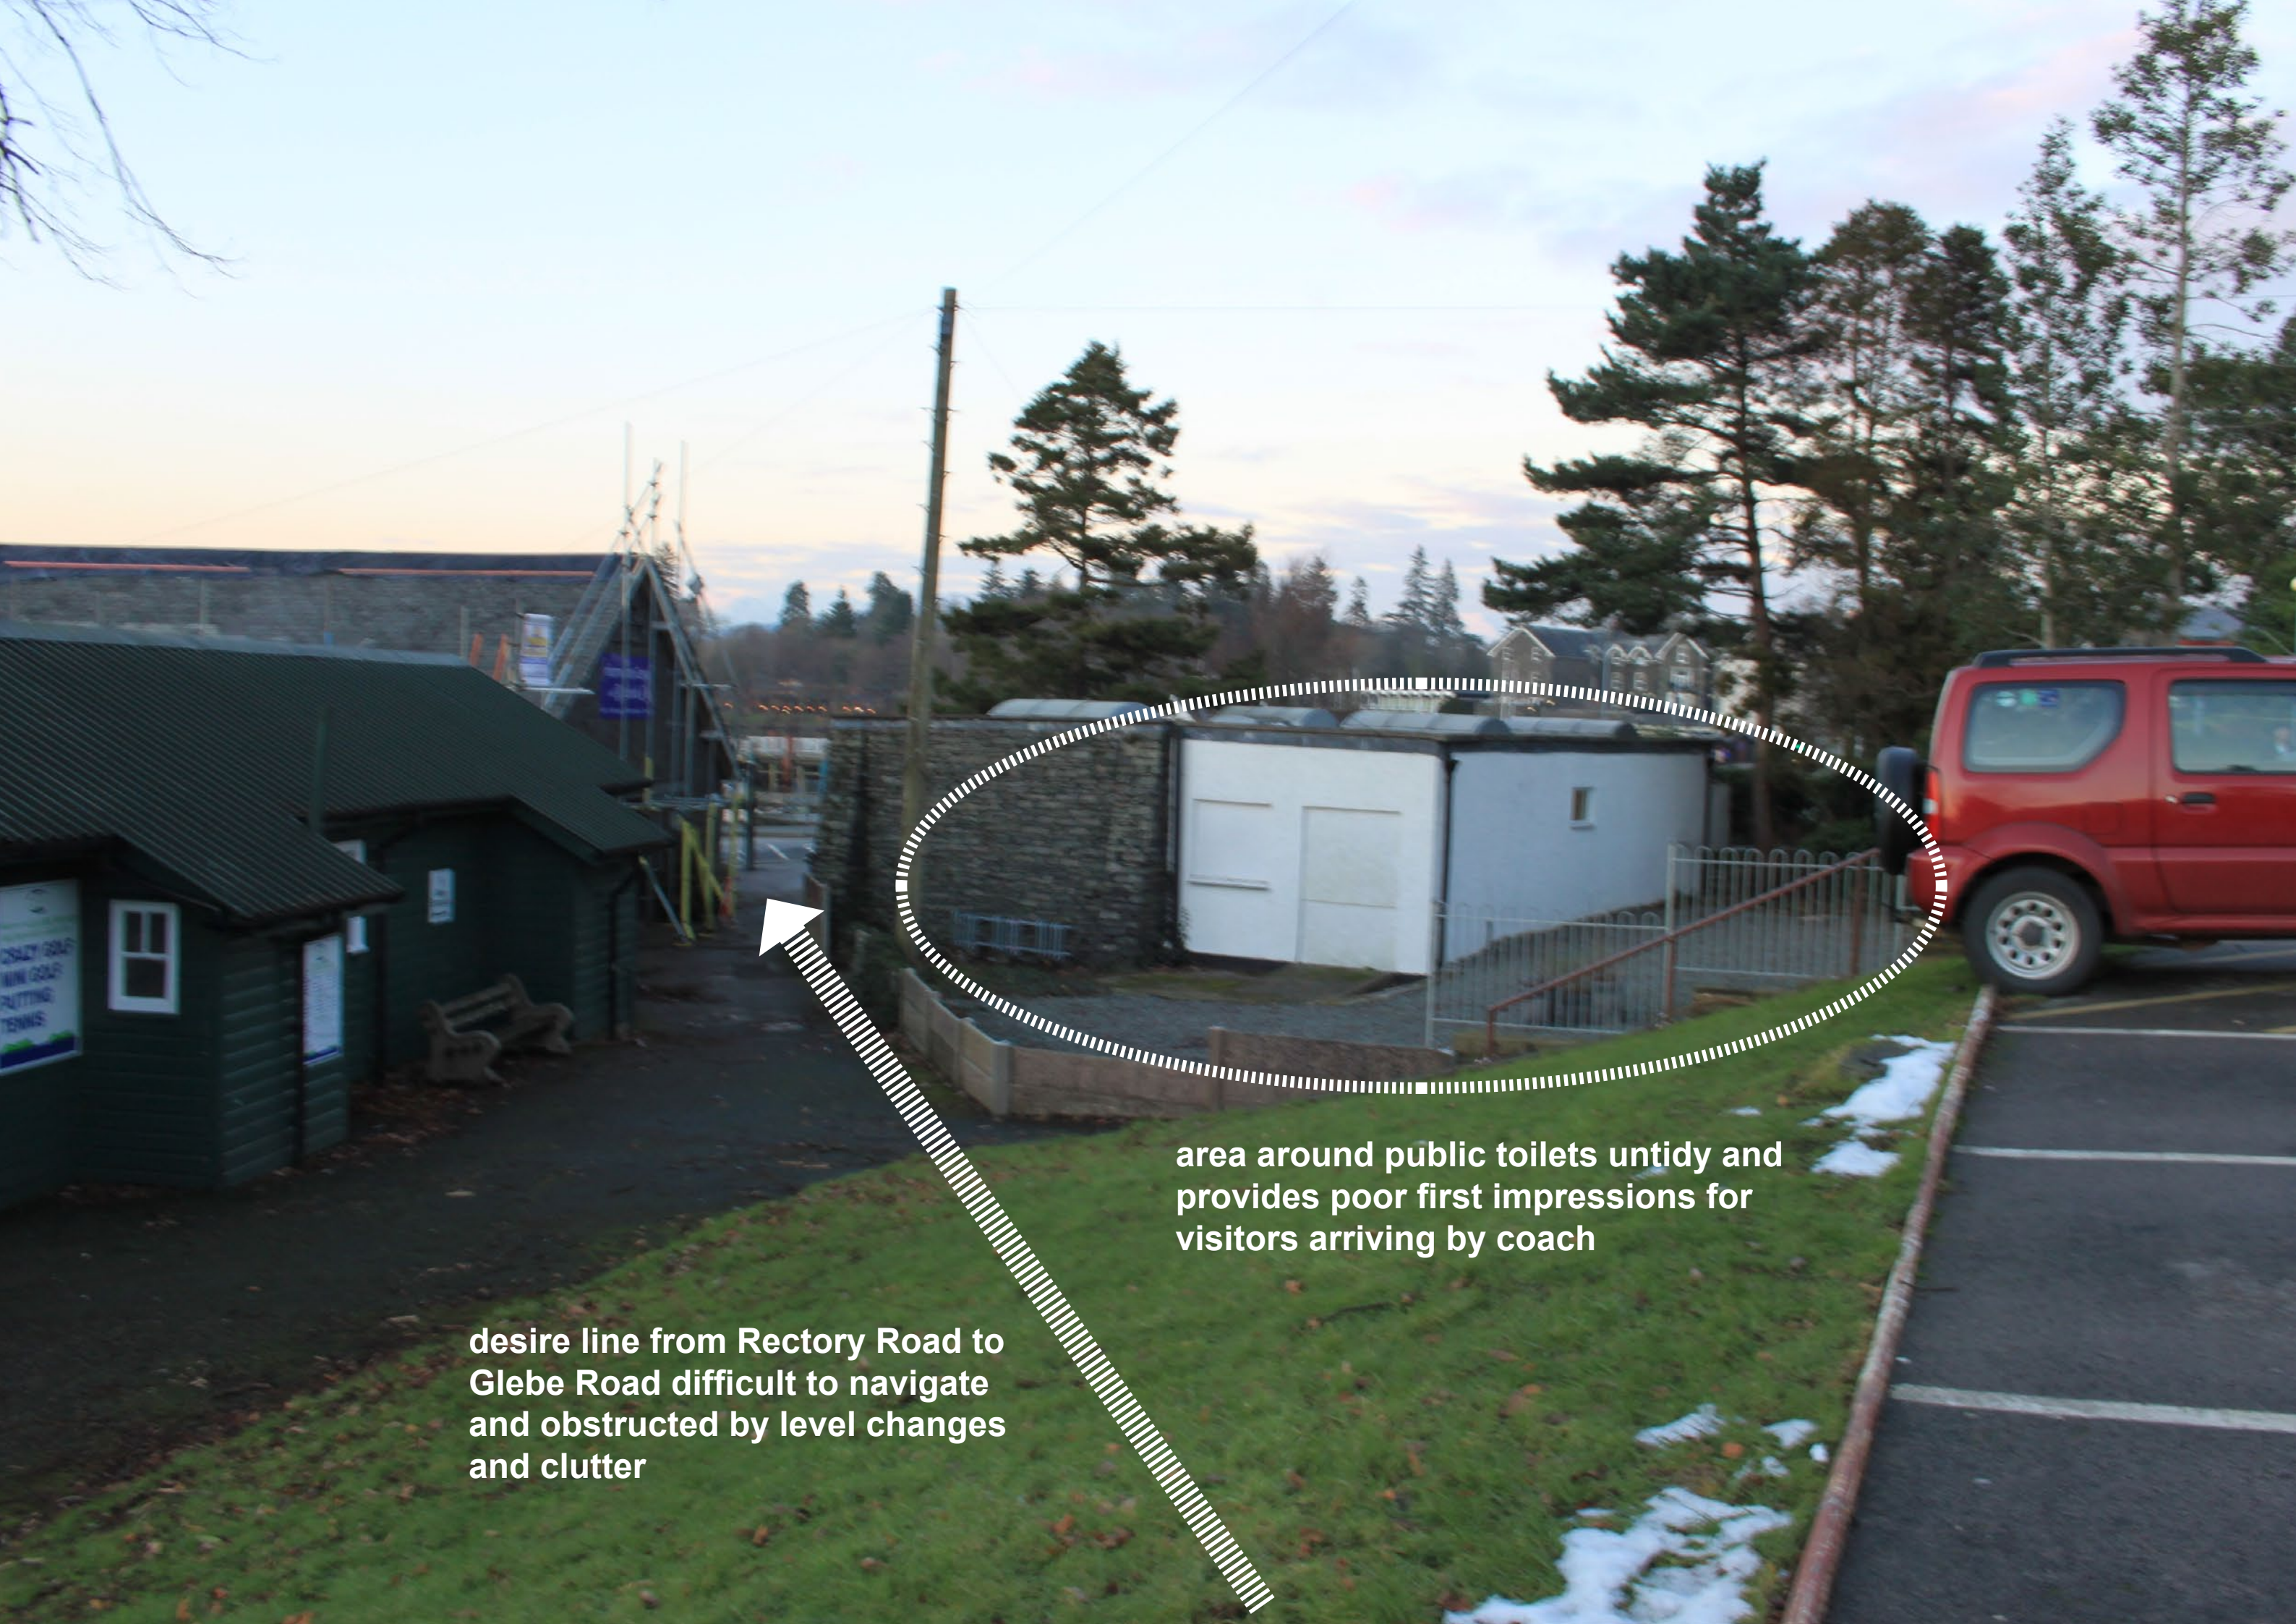
scenic long distance views from elevated position behind public toilet blocks could be utilised with new building or public space
